Experimental and analytical investigation of dynamic crack patterns in automotive windshield sheets subjected to low velocity impact

Abstract

In this study, some drop ball tests in different impact energy levels are conducted in order to monitor fracture behavior of an off-road automotive windshield. Also dynamic crack patterns of laminated glasses are examined based on the impact energy levels and impact conditions. In addition, the acceleration which is imposed to impactor during the accident is recorded. The experimental results are compared to an analytical approach regarding the resultant impact force as well. There is a good agreement between the impact forces of experimental test results and analytical approaches ones. All in all, in low velocity impacts, impact energy releases through powdering region in impact area, radial cracks and strain energy in PVB. It is concluded that in lower impact energy levels, the higher impact speed, the more number of radial cracks. In addition, at higher energy levels, number of radial cracks decrease due to higher strain energy levels in PVB interlayer. Therefore, in low velocity impacts, number of radial cracks has reverse relationship

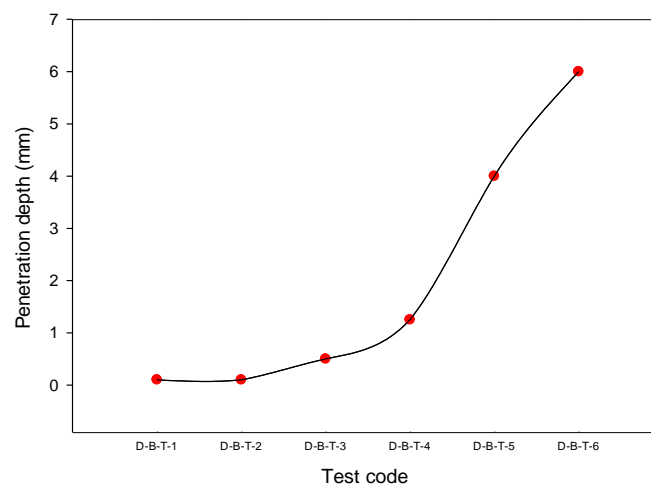
**Fig17.** Penetration depth in conducted drop ball tests

In addition, Number of radial cracks versus test code No is shown in Fig. 16. Also penetration depth graph at the center of specimens in different drop ball tests is shown in Fig.17

Test Code	Penetration Depth at the center of specimen	Number of Radial Cracks
D-B-T-1	0.1mm	67
D-B-T-2	0.1mm	62
D-B-T-3	0.5mm	62
D-B-T-4	1.25mm	84
D-B-T-5	4mm	30
D-B-T-6	6mm	24
