Experimental and analytical investigation of dynamic crack patterns in automotive windshield sheets subjected to low velocity impact

Automotive Fluids and Structures Analysis Research Laboratory, School of Automotive Engineering, Iran University of Science and Technology, Tehran 16846-13114, Iran

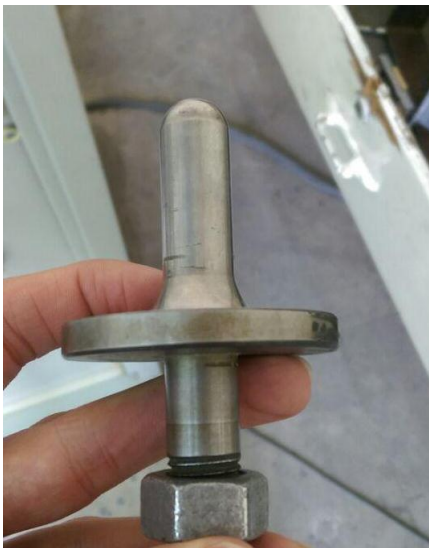
Fig2.Steel imp actor used in drop ball tests

The geometrical and mechanical properties of the impactor (which is depicted in Fig.2) are explained in Table 2.

Geometrical properties	Mechanical properties
Spherical part: Diameter= 16mm	Material: steel
Cylindrical part: Height 45mm	E= 200GPa, $\mu=0.3$
