Study of the effect on manufacturing parameters on the fatigue behavior of aluminum engine mounting bracket

ARTICLE INFO	ABSTRACT
<p>Article history:</p> <p>Received : 8 Jun 2024</p> <p>Accepted: 27 Sep 2024</p> <p>Published: 21 Oct 2024</p> <p>Keywords:</p> <p>Engine mounting bracket</p> <p>Manufacturing parameters</p> <p>High cycle fatigue</p> <p>Fatigue crack propagation</p> <p>Strength improvement</p>	<p>The engine mounting bracket connects the engine to the car body and plays a key role in reducing vibrations and supporting the engine's weight and dynamic loads. It must be designed to withstand cyclic forces during normal use but fail safely in high-impact situations, like accidents, to minimize damage. This study examines how manufacturing parameters affect the fatigue performance of aluminum engine mounting brackets in cars. According to the staircase-Locati fatigue test results, the relative mean resistance load was measured at 1.24 with a relative scatter of 0.07, placing it in the unsafe operating region for the engine mounting bracket. To address this, a finite element analysis was carried out to identify critical areas on the part and implement modifications to enhance

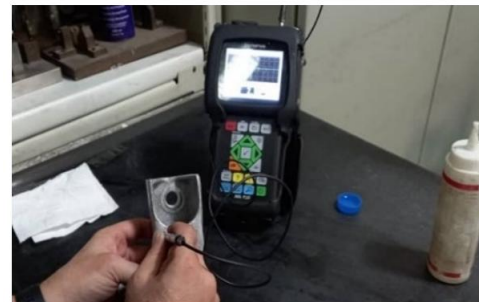
In order to investigate the reasons for the failure of the prototype in the external shell, a 3D scan was prepared by an optical device made by the Spanish company Nub 3D with a 1.5-megapixel camera lens. Also, the obtained data was entered in the SolidWorks software for the purpose of 3D modeling, which is shown in Figure 7. Finally, with the investigation, it was found that the outer shell of the initially produced part matches with the main designer of the part, so the outer shell of the part cannot be the cause of failure. After examining the outer shell, the thickness of the wall of the produced part was examined by the ultrasonic device made by the American company Olympus, model 38DL-Plus. After obtaining the thickness of the produced part, it was found that in some parts of the wall, such as point 16, the ultrasonic device shows less thickness, but referring to the reports after the test, no cracks were observed in these parts. As shown in Figure 8, the low thickness in these parts cannot be the reason for failure in the part.

Figure 7. a) 3D scanning of the external shell with an optical device. b) preparation of a 3D model of the external shell of the prototype in SolidWorks software.
