Experimental and analytical investigation of dynamic crack patterns in automotive windshield sheets subjected to low velocity impact

P. Shojaei Shahmirzadi, H. Saeidi Googarchin*

Automotive Fluids and Structures Analysis Research Laboratory, School of Automotive Engineering, Iran University of Science and Technology, Tehran 16846-13114, Iran

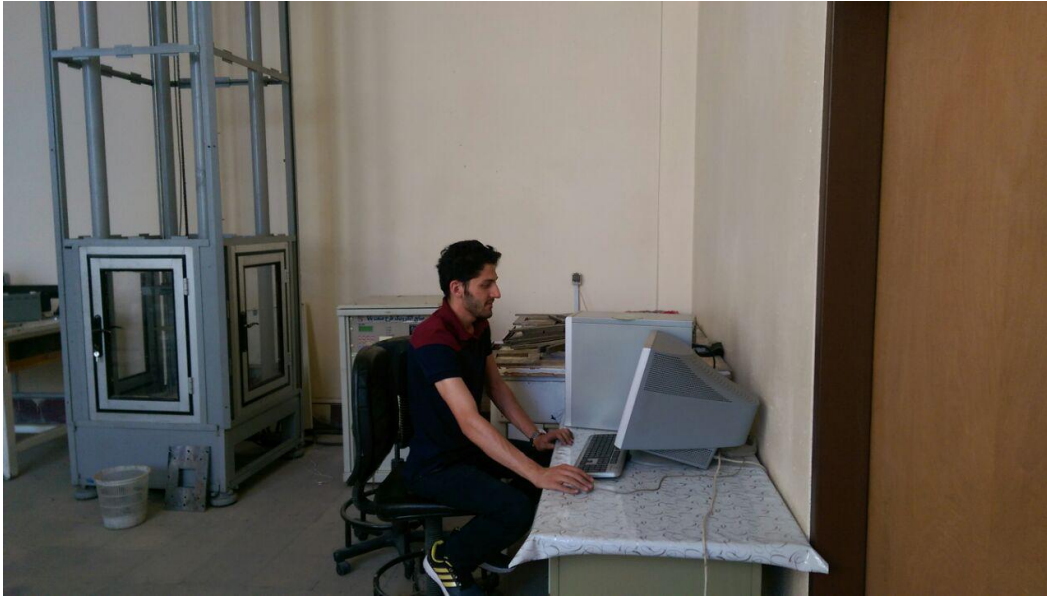
Fig1. Drop ball test machine used for experimental tests

The experiments were conducted on a drop ball testing machine (shown in Fig.1) equipped with accelerometer to investigate the laminated glass temporal response after the impact of a hard sphere. Some other specifications of the machine are shown in Table 1.

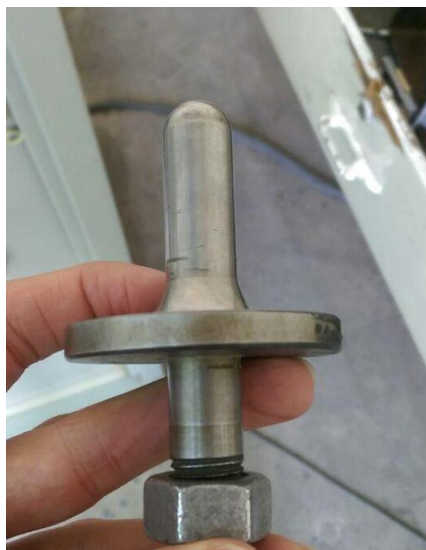
Fig2. Steel imp actor used in drop ball tests

The geometrical and mechanical properties of the impactor (which is depicted in Fig.2) are explained in Table 2.

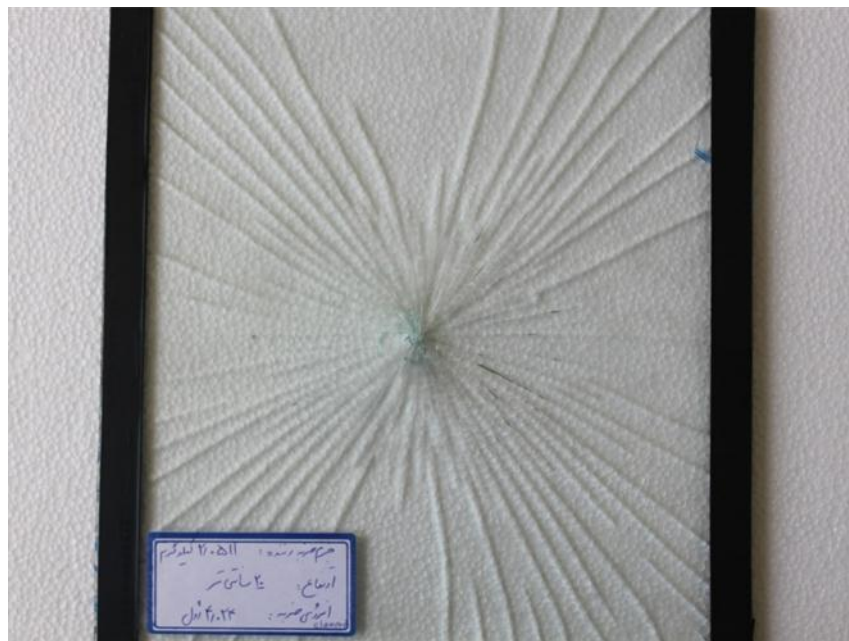
Fig4..specimen after test code D-B-T-1

Laminated glass specimen after test code D-B-T-1 is shown in Fig. 4.

As it is observed from Fig. 4, the impact region at the center of specimen is a circle with approximate diameter of 3mm. Indeed, due to low energy of impact, the impactor has not caused remarkable damage at the impact area. In addition, the impactor has not penetrated in the specimen and damage is superficial. As a matter of fact, the impact energy has been released through radial cracks propagation and the impactor has not had any penetration in the specimen.

It can be inferred from Fig. 4 that the radial cracks in test code D-B-T-1 are nearly symmetrical and about 67 from which this quantity, 60 cracks have been extended to the borders of specimen and released their energy

through reaching the border of specimen. As a consequence, the damage mode is dynamic crack propagation. In this specimen, no circumferential crack is observed which can be due to low level of impact energy. Consequently, it seems that although all the impact procedure occurs in less than some milliseconds, radial cracks are made at the first stage. At the vicinity of impact region, some sectors of circles are observed which are distributed sporadically to the approximate radius of 6mm from the center of specimen. Moreover it can be seen from Fig. 4 that the radial cracks have been propagated from the impact surface of laminated glass. On the other hand, the radial cracks in this specimen are superficial and have not reached the lower surface of specimen, hence it can be understood that the fracture of laminated glass begins with superficial cracks at the upper surface of specimen.

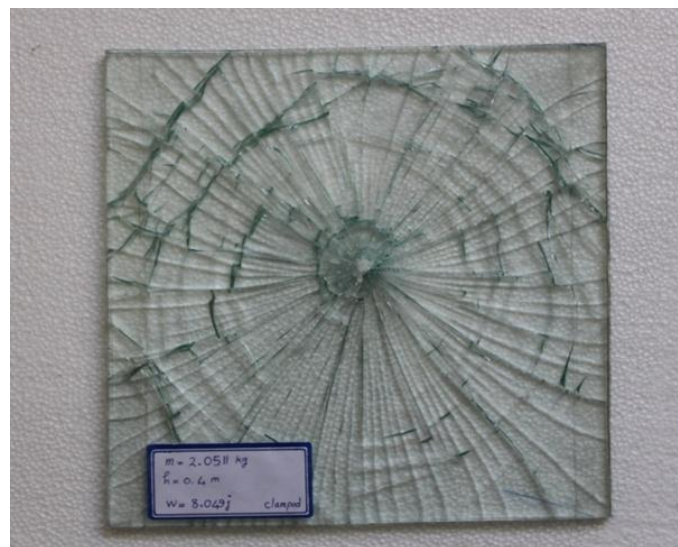
Fig10. .specimen after test code D-B-T-4

Laminated glass specimen after test code D-B-T-4 is shown in Fig.10.

As it is observed from Fig.10, the impact region at the center of specimen (powdering region) is a circle with approximate diameter of 20mm in which cracks density and consequently damage level is higher than the other regions of specimen. The projectile has penetrated to the depth of 1-1.5mm of the laminated glass and due to 2.5mm thickness of glass layers, no elongation has been occurred in PVB interlayer. Although energy level of test code D-B-T-4 is higher than test code D-B-T-3's one, penetration at the center of specimen is less in test code D-B-T-4 which

can be representative of impactor's mass influence. In test code D-B-T-4, the impactor mass is 2.0511kg, while it is 2.0712kg in test code D-B-T-3, therefore it can be concluded that in 2 similar conditions, the less impactor mass, the less penetration depth at the center of specimen.

It is easily seen from test code D-B-T-4 specimen that cracks have initiated from the impact surface and propagated through thickness. In this test, one circumferential crack has been propagated which is at the radius of 95mm from the center. Besides, some sectors of circumferential cracks have been made at the

radiuses of 62, 70 and 80mm from the center of specimen and serve as bridges to connect radial cracks. Also it can be seen from the laminated glass that the radial cracks in test code D-B-T-4 are nearly symmetrical and about 84. After drawing a comparison between test code D-B-T-4 and test code D-B-T-3, it is obvious that radial cracks of test code D-B-T-4 are more than their counterparts in test code test code D-B-T-3, on the other hand circumferential cracks of test code D-B-T-3 are more than test code D-B-T-3's ones. At test code D-B-T-4, distance between radial cracks is shorter than its corresponding item in test code D-B-T-3.

At all 4 sides of specimen which was clamped during the test, diagonal asymmetrical

net shaped cracks have been made which have created some right triangles in margins of the specimen. Diagonal net shaped cracks at the margins of test code D-B-T-4 specimen are more congested in comparison to the whole radial cracks. In addition, at both upper and lower glass layers, radial cracks converge at the center of the specimen and their divergence increases at larger radiuses. The acceleration versus time graph of test code D-B-T-3 is illustrated in Fig.11. As it can be seen from the graph, the maximum acceleration imposed to projectile is 732.0356m/s^2 which is occurred at 0.000131s .

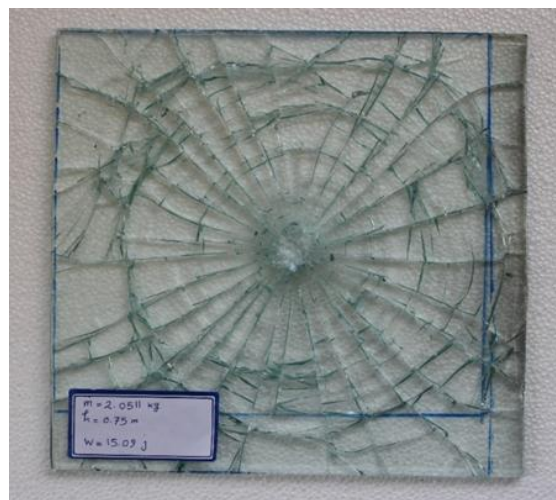
Fig12. .specimen after test code D-B-T-5

Laminated glass specimen after test code D-B-T-5 is shown in Fig.12.

As it is observed from Fig.12, the impact region at the center of specimen (powdering region) is a circle with approximate diameter of 20mm in which cracks density and consequently damage level is higher than the other regions of specimen. The projectile has penetrated to the depth of 4mm of the laminated glass, indeed the upper layer glass has fractured and PVB interlayer has elongated, but no tearing is observed. At the center of test code D-B-T-5 laminated glass, penetration depth has increased in comparison to test codes D-B-T-4 and D-B-T-3. Total number of circumferential cracks of the specimen is 5 which are placed at 47, 70, 80, 90 and 105mm distance from the center. At the vicinity of borders (close to clamping spots), net shaped diagonal cracks are more congested. Cracks have been propagated from the impact surface of laminated glass. At all 4 sides of the specimen, diagonal asymmetrical net shaped cracks have been made. At both upper and lower glass layers, radial cracks converge at the center of the specimen and their divergence increases at larger radiuses. Most of radial cracks have reached the borders of specimen and released their internal impact energy by this way.

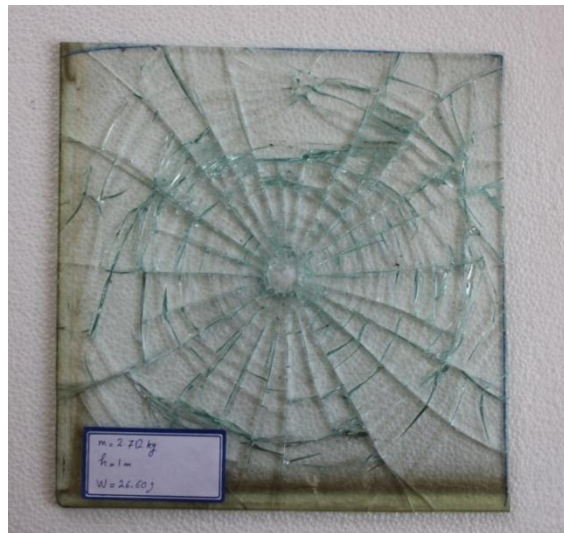
Fig14. .specimen after test code D-B-T-6

Laminated glass specimen after test code D-B-T-6 is shown in Fig.14.

As it is observed from Fig.14, the impact region at the center of specimen (powdering region) is a circle with approximate diameter of 20mm in which cracks density and consequently damage level is higher than the other regions of

specimen. In this test, the projectile has penetrated thoroughly in specimen. Therefore the glass layers have fractured and the PVB interlayer has torn. This test (test code D-B-T-6) has higher impact energy level in comparison to test code D-B-T-5. It can be observed that the penetration at the center of test code D-B-T-6 specimen is deeper than test code D-B-T-5, on the other hand the number of radial cracks is smaller in test code D-B-T-6. In fact, the impact energy has been released mostly through penetration in thickness direction and residual energy has released through radial and circumferential cracks. The radial cracks in test code D-B-T-6 are nearly symmetrical and about 24 which has decreased about 20% in comparison to test code D-B-T-5, but the penetration depth has

increased about 50%. It shows that approximate 76% increase in impact energy level in test code D-B-T-6 in comparison to test code D-B-T-5, has been released mostly through increase in penetration depth and radial and circumferential cracks in further priorities.

There are 6 circumferential cracks in the specimen at the radiuses of 34,41,51,60, 70 and 95mm from the center of the laminated glass sample. It can be seen from Fig.14 that the radial cracks have been initiated from the impact surface of laminated glass and propagated along thickness direction. In one side of the laminated glass, sectors of circumferential cracks like grids, have connected radial cracks to each other. 12 out of total 24 radial cracks have extended to the borders of the specimen and released their internal impact energy by this way. The acceleration versus time graph of test code D-B-T-6 is illustrated in Fig.15
