# A historical experience of local seismic proof shelters in Quchan-northeast of Iran

F. Mehdizadeh saradj<sup>1,\*</sup>, E. Moussavian<sup>2</sup>

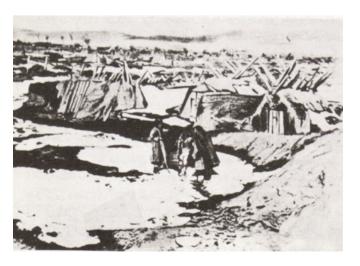
Fig. 2 Earthquake-proof "A shaped" shelters of Quchan [1]

In 1875, McGregor described a new kind of structure innovated by the local people for being used as a shelter against severe climatic condition of the region [6]. The shape of these shelters looked like a tent (Fig. 2) and Yate (1894) resembles them to wigwams [7]. These new constructions had no walls and seemed as if gable roofs placed on the ground. People were erecting old timbers pulled out of ruins against the ridge pole and then plastered them with bushes and mud [5]. More detailed features of these shelters in addition to the process of their extension through the years following the quakes will be described in section 3.

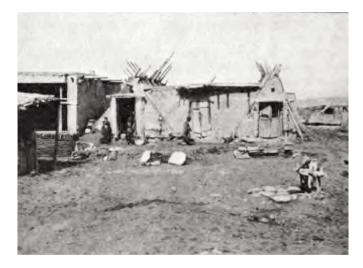
Fig. 3 Extended model of "A shaped" shelters consist of 2 tentmodels bridged with a flat roof [11]

The earthquake proof feature of these shelters which is described above, led to their further extension after the 1895 earthquake. For the extension, at first, two primary structures of "A shaped" shelters were set up. Most of the time one of them is erected and settled before. Then, a flat-roof room connects the two shelters to one another [11]. The structure of this flat roof was made of timber beams parallel to the ridge beam of "A shaped" frames. Each of the three parts of these dwellings had a separate entrance (Graphic 1-D).
