## Experimental in-plane behavior and retrofitting method of mud-brick walls

F. Tootoonchy, B. Asgarian\*, F. Danesh

### Abstract

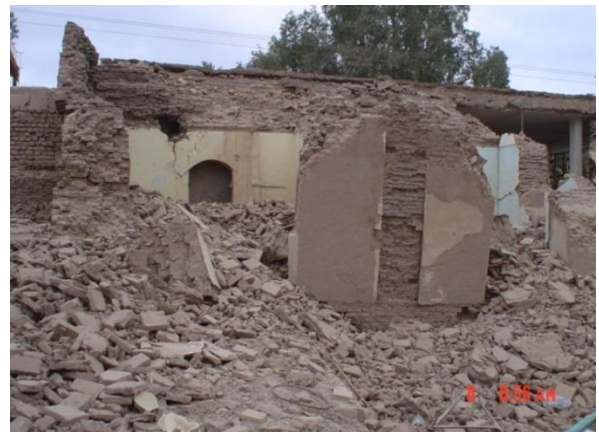
Fig. 1 A view of one sample destroyed adobe house after Bam earthquake

Adobe building made from mud-brick is a construction system that uses mud-brick to form bearing or non-bearing walls. It is estimated that about 30% of world's population lives in adobe and mud-brick buildings. In addition a number of historical and archeological building made from mud-brick. A lot of mud-brick buildings are in seismic active areas. As mud-brick is very brittle and low-strength material with heavy mass. Building made from this type of material are highly vulnerable in seismic active areas. A sample of destroyed adobe house after Bam earthquake is shown in Fig. 1.

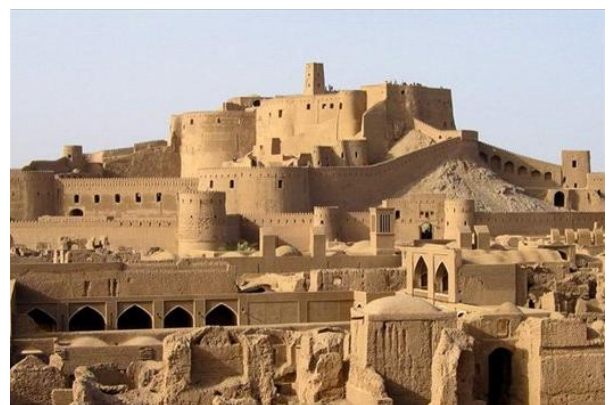
**Fig. 2** View of Bam Citadel before and after Bam earthquake

The largest mud-brick structure is the Bam citadel which has been suffered serious damages during 2003 Bam earthquake. During Bam 2003 earthquake, most of the adobe buildings were destroyed, more than 26,000 people were died and over 60,000 were left without shelter [1]. Fig. 2 shows Bam citadel before and after 2003 earthquake.

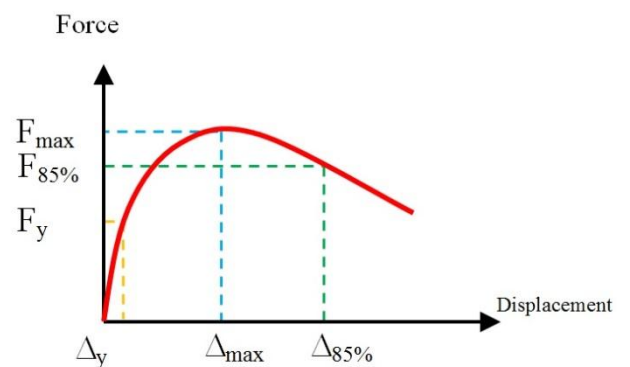
Fig. 8 Effective parameter in explaining ductility of behavior of a structure on its behavior curve

- $\mu_Y$ : Ductility of the wall
- $\Delta_{yield}$ : Lateral displacement of wall at yield point
- $F_Y$ : Load at yield point
- $F_{max}$ : Maximum imposed load to wall
- $\Delta_{max}$ : Displacement of wall correspond to  $F_{max}$
- $F_{85\%}$ : 85 % of maximum imposed load to wall
- $\Delta_{85\%}$ : Displacement of wall correspond to  $F_{85\%}$  in degrading branch

Above parameters are shown in Fig. 8.

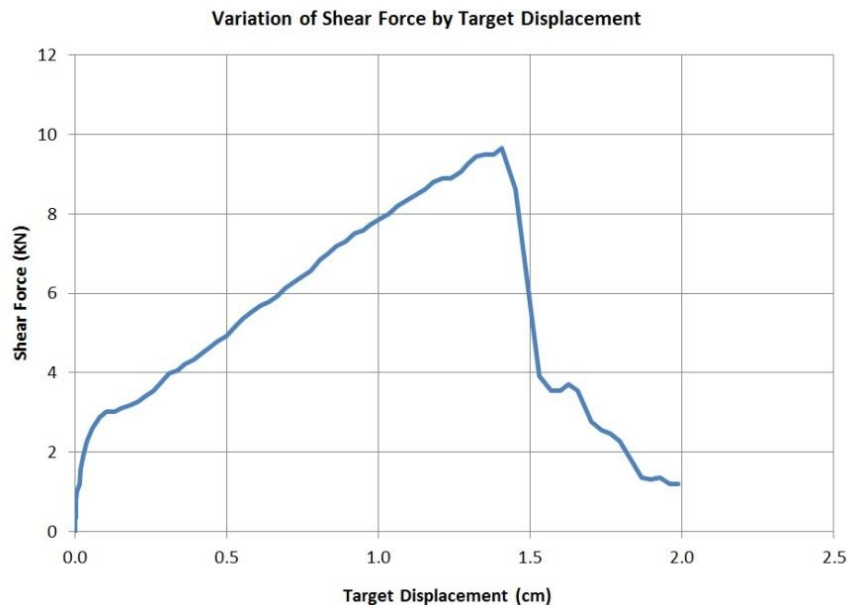
Fig. 10 Curve of shear force against sliding displacement of wall crown MW1

Shear force-lateral displacement curve of MW1 is shown in Fig. 10. Short initial elastic behavior can be observed at the start of the test which was then adjusted by forming a crack in the bed joint. Then, a sudden strength fall was observed during rocking motion mechanism.

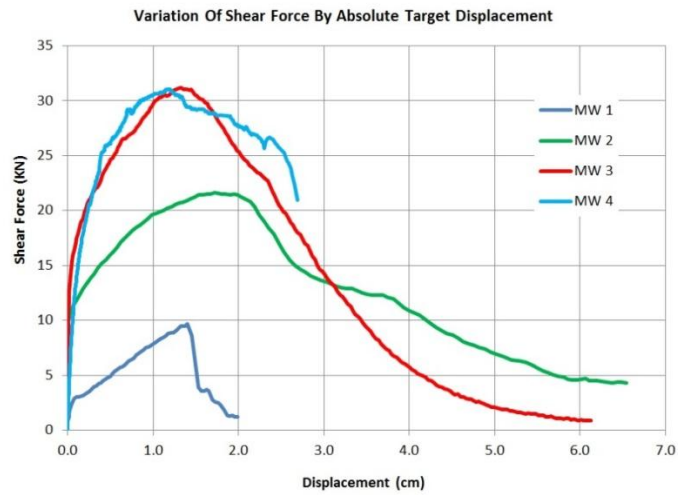
**Fig. 13** Comparison of shear curve of MW1, MW2, MW3, MW4 walls

Fig. 13 compares shear force-lateral displacement curves of MW1, MW2, MW3 and MW4 in which effect of compressive stress and friction between joints caused improvement of strength and ductility. Sudden break of MW4 wall compared to the first three walls was observed since this wall has suddenly lost its load bearing capacity due to high vertical stress in wall.

Shear capacity ( $F_{max}$ ) and displacement of walls correspond to  $F_{85\%}$  in degrading branch ( $\Delta_{85\%}$ ) is presented in Table 2. As the significant point for the yield of the walls cannot be introduced from Fig. 13, ductility of the walls is not presented directly. However, ductility of the walls without and with proposed retrofitting method can be screened by observation of the walls behavior. It can be seen that the shear capacity of the walls was increased in presence of vertical stress. Meanwhile, ductility of the walls was also increased as the vertical stress was increased except sample No. 4 which has failed due to high vertical load.

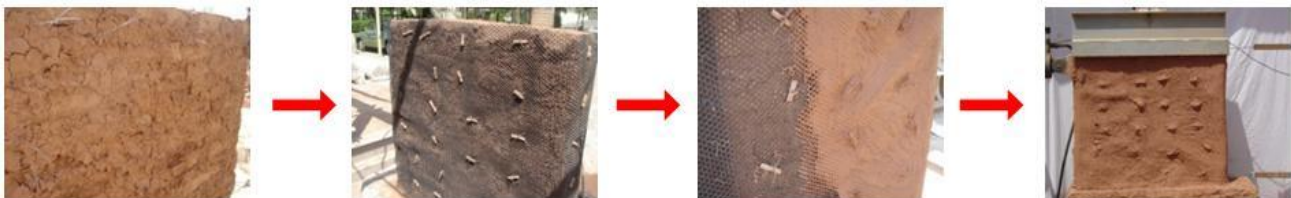
**Fig. 14** Installation process of polypropylene lace on adobe walls

behavior and to prevent the wall uplift and rocking motion mechanism was proposed. For this purpose, RMW1 is surrounded only by polypropylene lace. After installing twisted wires in the wall at a distance of about  $0.2^m$ , this net is fixed to the wall and then it is filled with clay mortar. The proposed method is a simple and cheap way which can be executed by an un-skilled labor. In the proposed method, when the wall is subjected to lateral loads, a tension force occurs in membrane net of polypropylene lace; by increasing the wall volume, its reaction is imposed on the wall in the form of a pressure confining force. It causes an increase in the shear capacity, ductility and energy absorption of the retrofitted wall compared to original ones. Fig. 14 shows the installation stages of the proposed method. Table 1 also shows the details of a test performed on a reinforced wall with polypropylene lace.

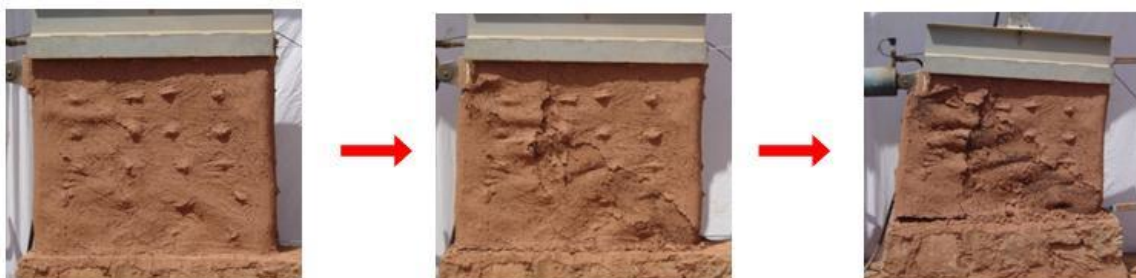
**Fig. 15** Damage mechanism of RMW1 wall

To compare the results, a vertical uniform load same as MW3 was applied to retrofitted walls and then the lateral displacement was applied to walls. Fig. 15 shows the views of the RMW1 during the test. It can be seen that the volume of the wall toe was increased during test and the surrounding net was stretched. Then, the volume of the wall was increased around the wall diagonal. Moreover, diagonal cracks were formed without any collapse despite the fact that wall underwent a considerable deformation. Ultimately, rocking motion mechanism was formed following appearance of diagonal cracks. Fig. 16 presents variation of shear force against lateral displacement of RMW1 wall.

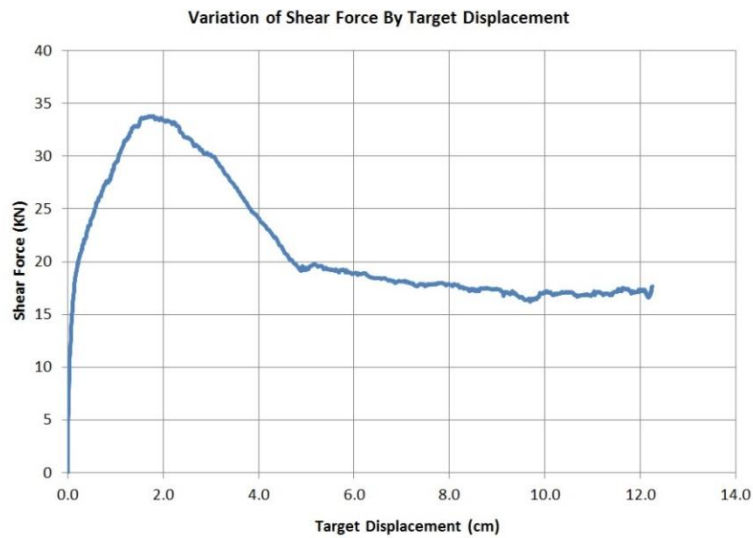
**Fig. 16** Experimental behavior of RMW1 wall

It was observed that the application of polypropylene lace caused suitable cohesiveness of the wall compared to the behavior of the similar wall without proposed retrofit method (MW3). It can also be seen that using polypropylene lace resulted proper integrity of the wall. Actually, better performance of the wall was observed by postponing the occurrence of rocking motion mechanism. The sample RMW2 was connected to its foundation by tarpaulin belts (Fig. 17) in addition to using the polypropylene lace same as RMW1 sample. Adding tarpaulin belts helps the wall to postpone or even prevent rocking motion mechanism. Table 1 also shows the details of a test performed on RMW2.

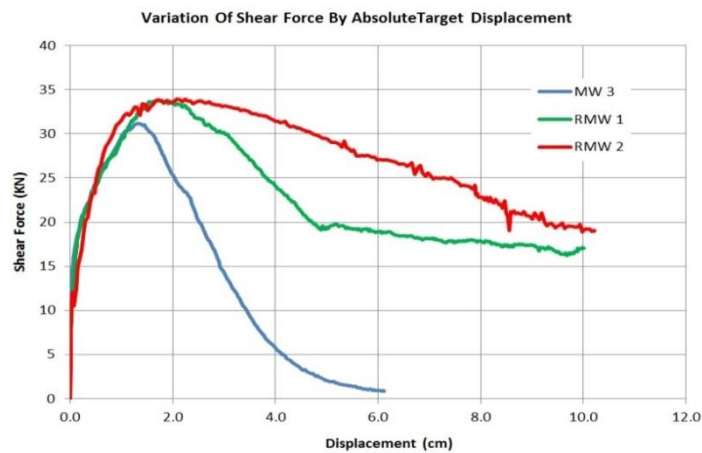
Fig. 20 Comparison of experimental behavior of MW3, RMW1, RMW2 walls

Shear force-lateral displacement curve of RMW2 is shown in Fig. 19. Fig. 20 compares shear force-lateral displacement of MW3, RMW1 and RMW2. This Fig.

shows that proposed retrofitting method increases shear capacity and energy absorption of the mud-brick wall significantly.

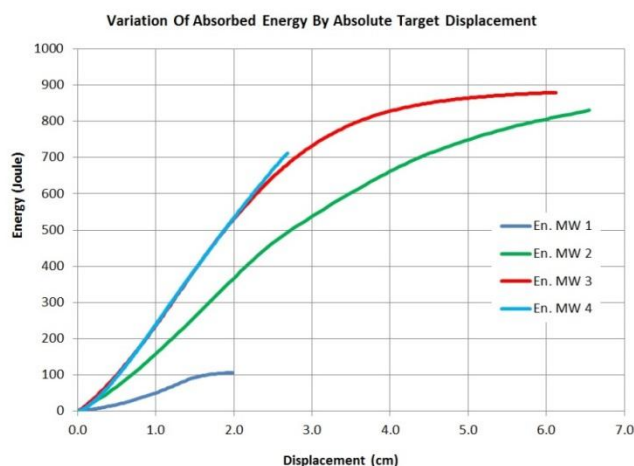
Fig. 21 Comparison of energy-displacement curve for sample walls without retrofit

The shear capacity of the wall and its lateral displacement corresponded to 85% of the shear capacity are also shown in Table 2. It can be seen that by retrofitting the wall in addition to increasing shear capacity of the wall, its ductility and energy absorption were increased significantly. The energy deformation curves of the walls without and with proposed retrofitting method are presented in Figs. 21 and 22. It can be seen that the

energy absorption of the walls in large deformation area increased significantly for retrofitted walls. The results for the energy absorption until failure and maximum displacement of the walls are also presented in Table 3. It can be seen that by using proposed retrofitting method, a better performance can be achieved compared to the walls without retrofit.

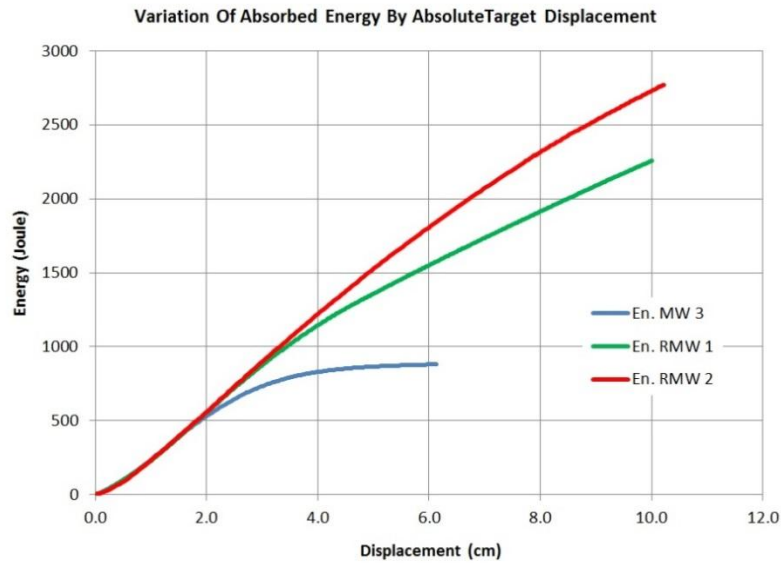
Fig. 22 Energy-displacement curve for retrofitted sample walls compared to non-retrofitted wall
