Technical Note

Repair effectiveness of CFRP and steel plates in RC beams with web opening: effect of plate thickness

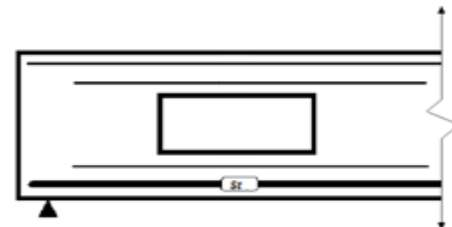
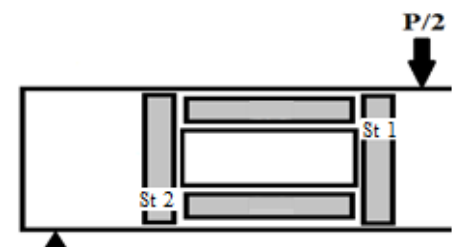
(b) Externally bonded plates
Fig. 2 Locations of strain gauge

The behaviour of load-strain relationship for externally bonded CFRP and steel plates is presented in this section. Strain gauge are fixed at two locations, one locations is on the opening corner near the support (ST2) and another location is at the opening corner near the point of applied load (ST1), as shown in Fig. 2(b). The load against strain curves for beams B1, B2, B3 and B4 are shown in Figs. 7, 8, 9 and 10, respectively. The recorded strains indicate that the value of strain for all beams did not reach the ultimate

The load-strain relationship of steel reinforcement is presented in this section. The strain gauge (St) was attached onto the main steel reinforcement bar at the middle of the opening in the bottom chord. Fig. 6 shows the load against steel bar strain of the strain gauge (St) at the pre and post repair stages. For all the beams at the pre-repair stage, the strain gauge (St) shows an increase in strain value with the

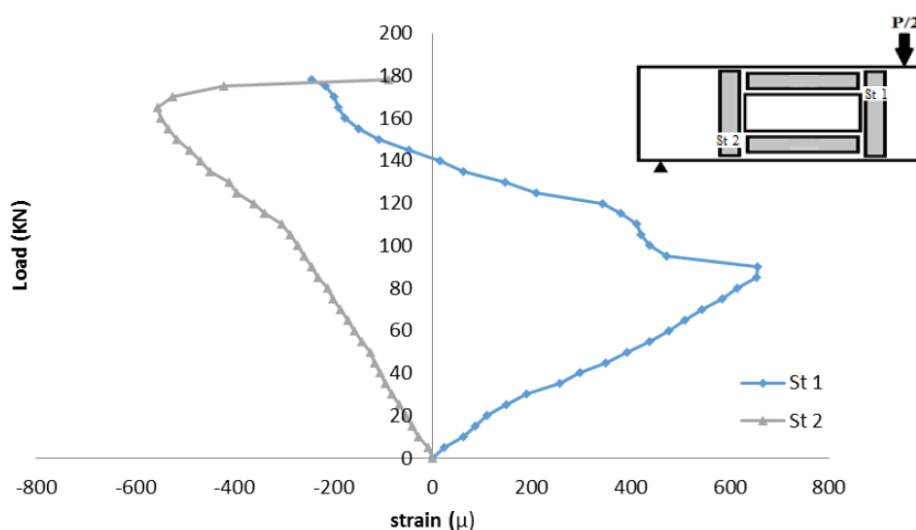
Fig. 7 Load against strain of externally bonded CFRP plates of beam B1

As can be seen from Fig. 7, for beam B1 the maximum CFRP strain measured at failure was in strain ST1. For beam B3, the steel plate strain measured at failure was deferent at each location, because the value of the strain greatly depends on the location of the strain gauge with respect to a crack, as shown in Fig. 9. It can be observed from Fig. 10 that for beam B4, the maximum CFRP strain measured at failure was in strain ST1, on the bottom chord of the opening. CFRP and steel plates were not fractured or debonded from the concrete surface, and this ultimately indicates that CFRP and steel plates could provide additional strength if the beams did not fail by concrete diagonal shear cracks.

strain of CFRP and steel plates. This is due to the fact that the concrete failed before allowing the repair materials to reach the ultimate strain values. It can be observed from Figs. 7 to 10 that the externally bonded plates start to share the strain in the beam from the start of the applied load. The results are in agreement with Khalifa and Intomio [20], who found that the maximum CFRP vertical strain measured at failure corresponded to 14 % of the reported CFRP ultimate strain. This value is not absolute, because it greatly depends on the location of the strain gauge with respect to a crack.

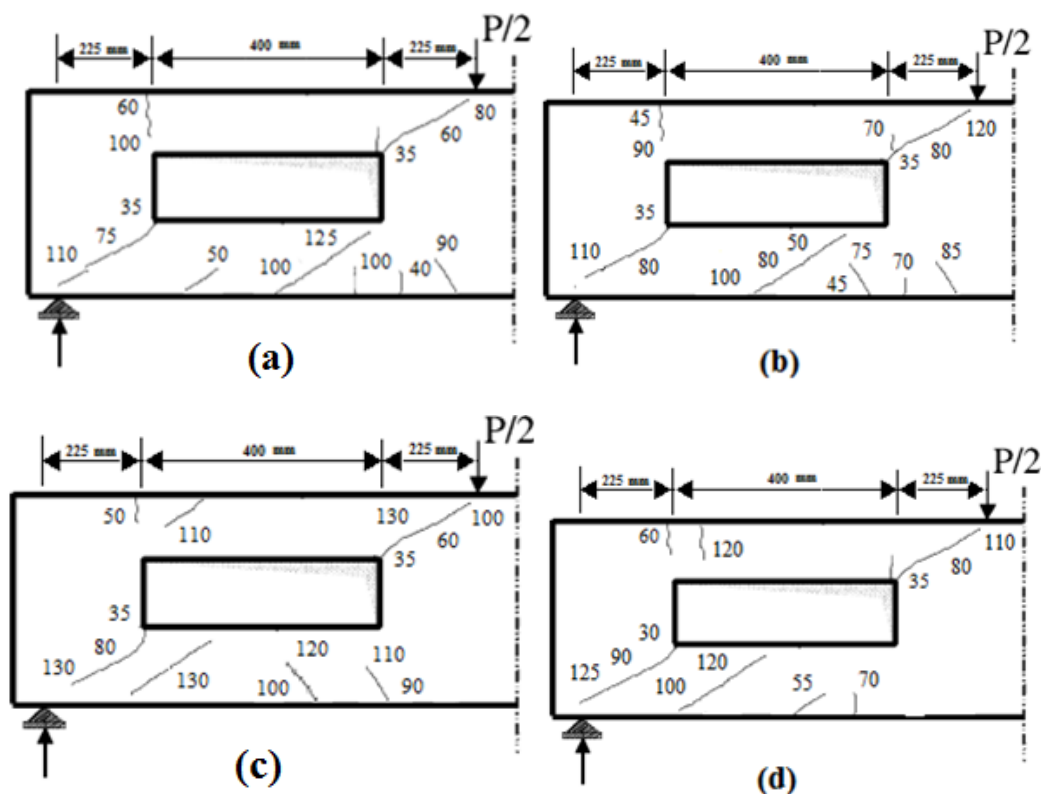
Fig. 11 Crack patterns and failure modes of beams at the pre-repair stage (a) Beam B1, (b) Beam B2, (c) Beam B3, (d) Beam B4

The crack pattern and the failure modes for all beams at pre and post repair stages are presented in this section. Figs. 11 and 12 show the crack pattern and the failure mode for all the beams at the pre and post repair stages, respectively. The failure modes of all the beams are similar because the failure occurs due to failure in concrete as diagonal shear failure before the externally bonded plates reach the ultimate strain. It can be seen from Fig. 11 (b) that the first diagonal crack for beam B2 was observed at the corner of the opening at a load of 35 kN; additional cracks were formed with the increase of the applied load. Failure of the beam occurred when the total applied load reached 128 kN. At the post-repair stage, many cracks were formed at the solid span of the beam, and the failure of the beam occurred at a load of 163.4 kN. At failure, concrete diagonal shear failure was observed around the
