## Investigation of long term coupled effect of high temperature and constant high humidity on corrosion rehabilitated patches of reinforced concrete structures

### Abstract

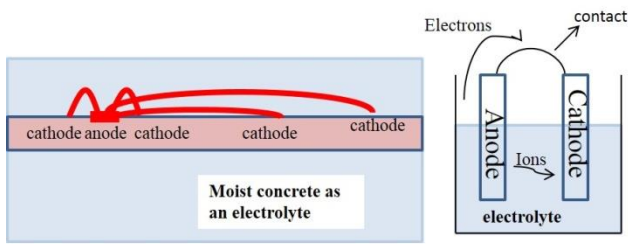
Figure 1 Separation of cathode and anode

The authors of this research paper, previously investigated and established the phenomenon of macro-cell formation in the repaired reinforced concrete patches due to the separation of anode and cathode [9], which is illustrated in Fig. 1. They also corroborated that the presence of high chloride content aided by the severe environmental conditions i.e. varying temperature and high constant humidity, not only break the passive film which protects steel from further corrosion but also accelerate the corrosion of reinforcement steel bars even in repaired reinforced concrete patches [10]. However, what would be the effect of long term coupled effect of varying temperature and constant high humidity on macro-cell corrosion of such repaired RC patches remained a question and leads to the objectives of this research paper.

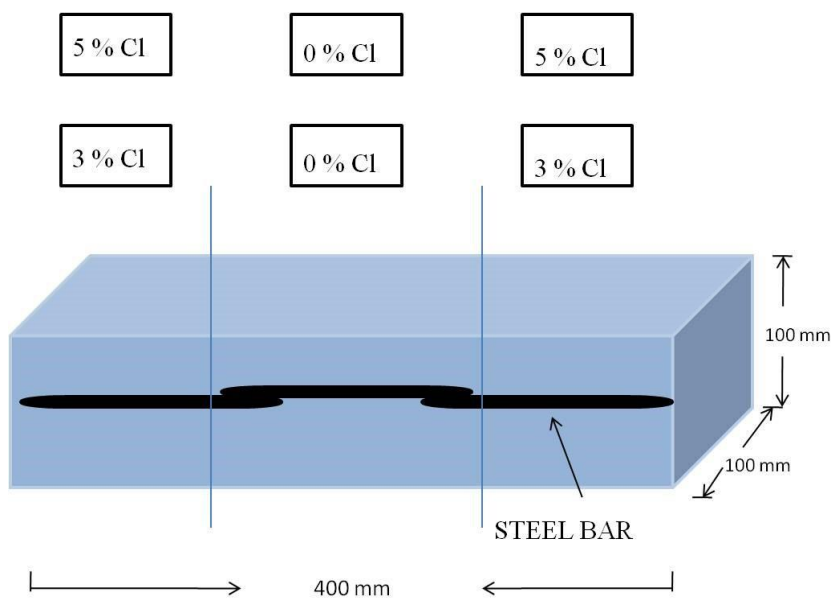
Fig. 2 Schematic representation of the identical test specimen

elsewhere [10]. The schematic diagram of these specimens is shown in Fig. 2 and the complete mixing procedure is shown in Fig. 3. Since the objective of this research is to find the long term coupled effect of varying temperature and high humidity on macro-cell corrosion phenomenon, these specimens were kept at 50°C, 40°C and 30°C temperature conditions and 85% relative humidity in environment control chambers for 2 years.

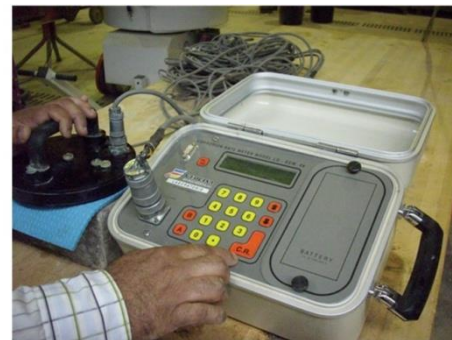
Figure 4 GECOR-8 (Corrosion Measurement device)

The steel rebar corrosion current ( $I_{corr}$ ) and corrosion potential ( $E_{corr}$ ) were measured for all specimens using a GECOR device [11] and ASTM C-876 [12]. The GECOR measures the corrosion rate as reflected by the corrosion current density and the half-cell corrosion potential. A true measure of the corrosion rate is possible by the polarization resistance technique. It has been well established by Stern and Geary that the corrosion current is linearly related to the polarization resistance, which gives a direct quantitative measurement of the amount of steel turning into oxide at the time of measurement. By Faraday's equation, this can be extrapolated to direct metal sectional loss. The corrosion current values in GECOR (GECOR-8, 2012) are calculated from the polarization resistance  $R_p$  using the relation  $I_{corr} = B/R_p$ , where  $I_{corr}$  is given in  $\mu A/cm^2$  when  $R_p$  is given in  $k\Omega/cm^2$  and  $B = 26$  mV. The  $I_{corr}$  is directly proportional to corrosion rate through the relation, corrosion rate ( $\mu m/year$ ) =  $11.6 \times I_{corr}$ . This gives a tool for quantifying the average reduction of rebar diameter over time. The measurement of corrosion rate usually involves applying electrical signal through a connection to the steel bar. In GECOR this signal is confined to the steel rebar in a circle with a diameter of 110 mm. There is evidence that this technique gives a more accurate measurement of the corrosion rate [13]. The GECOR device is quite valuable and versatile for the corrosion measurement of steel in concrete. See Fig. 4 for further illustration.

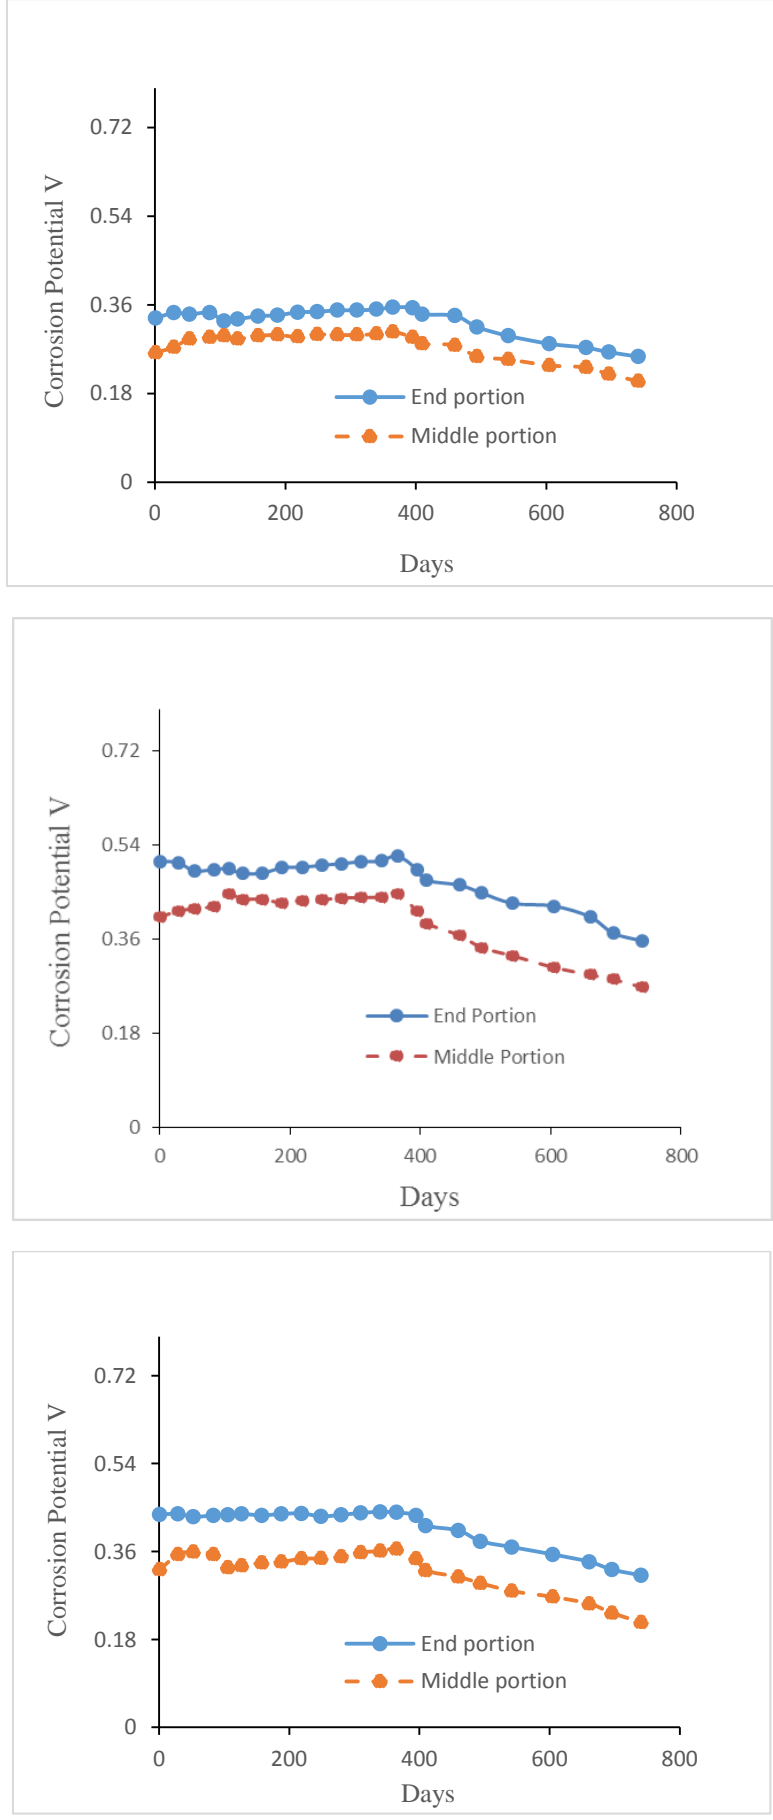
Fig. 6 (a-c) Corrosion potential measurement for 3% chloride contaminated specimen at the end kept at 30°C, 40°C and 50°C

1) At the middle non contaminated portion of the specimen having 5% chloride at the end portions and kept at  $50^\circ C$  (#1 and #2), the maximum corrosion of **-0.235** Volts was found after 2 years as compared to **-0.285** Volts at  $30^\circ C$  in the middle zero chloride portion of the same specimens (#5 and #6). However previously, much higher readings of these specimens were obtained on completion of one year observations [10]. The reason of this phenomenon could be the long term coupled effect of temperature and constant high humidity due to which the decline in corrosion potential after two years was significant. The results are shown in Figs. 5 and 6.

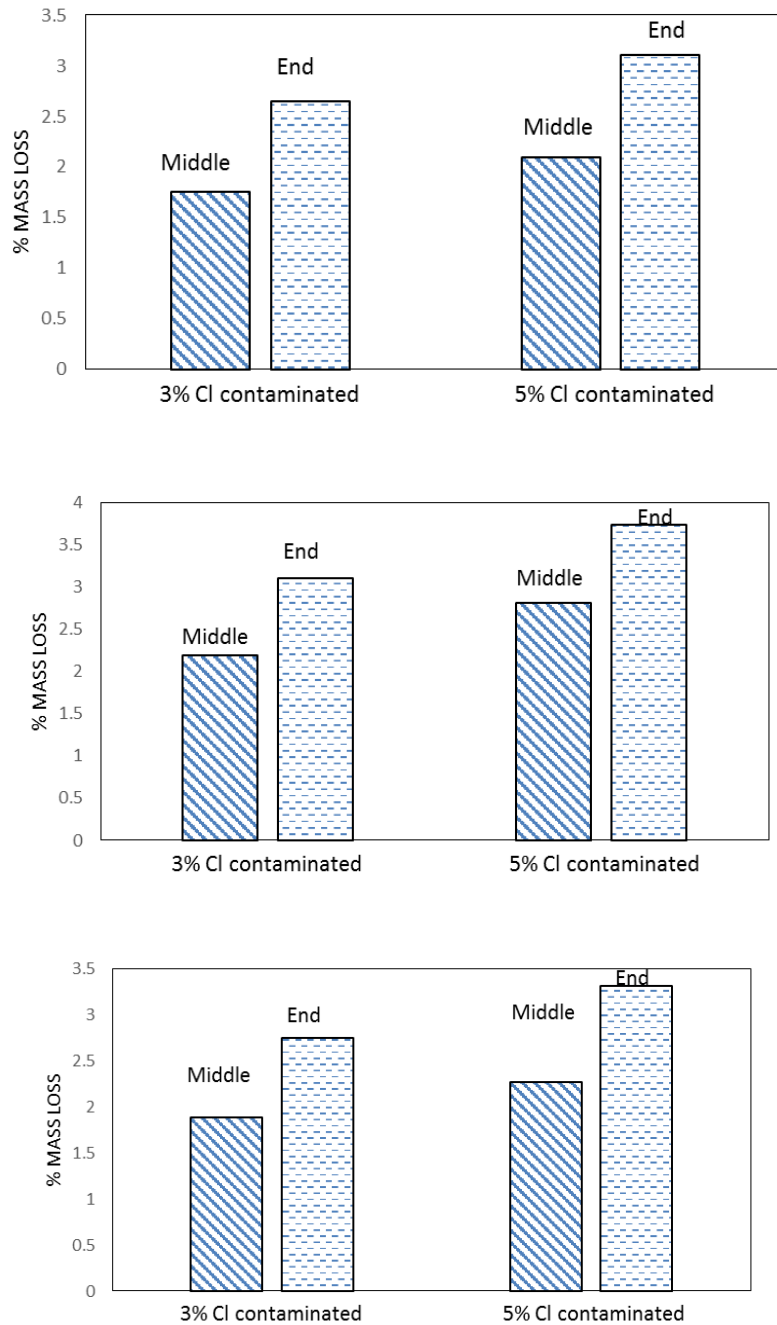
**Fig. 7** % Mass loss for 3% and 5% chloride contaminated specimen at the end kept at 30°C, 40°C and 50°C

steel of the end portion of the same specimen kept at 50°C gave the highest % mass loss of 3.31 and middle steel gave 2.27 % mass losses which was lower than the mass losses at 40°C. The results are shown in Fig. 7.

2) The steel from the end portions of 3 % chloride contaminated concrete specimens kept at 30°C, 40°C and 50°C gave 2.65, 3.11 and 2.75 % mass loss respectively. While the middle steels from the uncontaminated portion of these specimens gave 1.75, 2.19 and 1.88 % mass losses respectively as shown in figure 7. Similarly in the 3% chloride contaminated specimens reduced % mass losses at 50°C obtained as compared to the mass loss at 40°C, confirming the authenticity of the results of this research.

As it can be seen from gravimetric mass loss results of various specimens put in varying temperatures, shown in figure 7(a-c), the steels from the middle portion of all the specimens simulating the actual patch repair in field, were corroded and gave approximately 70% of the mass loss obtained in their respective contaminated end portions, indicating the chloride transfer and vulnerability of repaired portion against corrosion.
