Investigation of long term coupled effect of high temperature and constant high humidity on corrosion rehabilitated patches of reinforced concrete structures

M. Wasim¹, Raja Rizwan Hussain^{2*}, M. A. Baloch³

Abstract

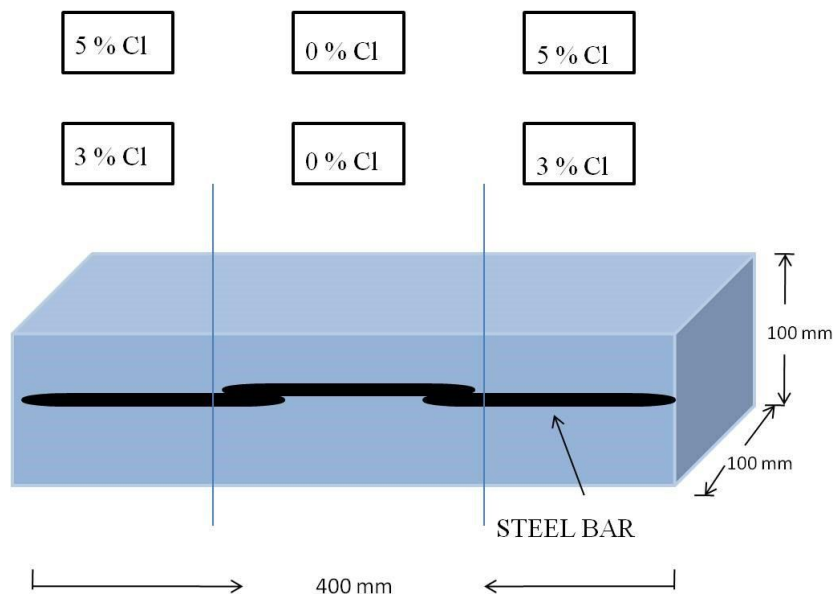
Fig. 2 Schematic representation of the identical test specimen

elsewhere [10]. The schematic diagram of these specimens is shown in Fig. 2 and the complete mixing procedure is shown in Fig. 3. Since the objective of this research is to find the long term coupled effect of varying temperature and high humidity on macro-cell corrosion phenomenon, these specimens were kept at 50°C, 40°C and 30°C temperature conditions and 85% relative humidity in environment control chambers for 2 years.

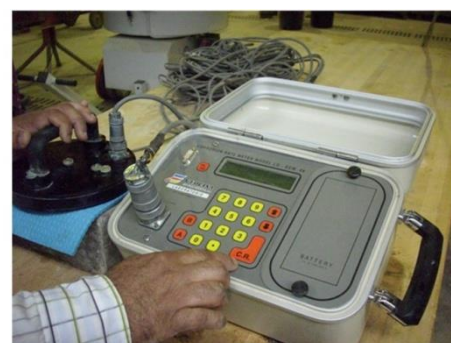
Figure 4 GECOR-8 (Corrosion Measurement device)

The steel rebar corrosion current (I_{corr}) and corrosion potential (E_{corr}) were measured for all specimens using a GECOR device [11] and ASTM C-876 [12]. The GECOR measures the corrosion rate as reflected by the corrosion current density and the half-cell corrosion potential. A true measure of the corrosion rate is possible by the polarization resistance technique. It has been well established by Stern and Geary that the corrosion current is linearly related to the polarization resistance, which gives a direct quantitative measurement of the amount of steel turning into oxide at the time of measurement. By Faraday's equation, this can be extrapolated to direct metal sectional loss. The corrosion current values in GECOR (GECOR-8, 2012) are calculated from the polarization resistance R_p using the relation $I_{corr} = B/R_p$, where I_{corr} is given in $\mu A/cm^2$ when R_p is given in $k\Omega/cm^2$ and $B = 26$ mV. The I_{corr} is directly proportional to corrosion rate through the relation, corrosion rate ($\mu m/year$) = $11.6 \times I_{corr}$. This gives a tool for quantifying the average reduction of rebar diameter over time. The measurement of corrosion rate usually involves applying electrical signal through a connection to the steel bar. In GECOR this signal is confined to the steel rebar in a circle with a diameter of 110 mm. There is evidence that this technique gives a more accurate measurement of the corrosion rate [13]. The GECOR device is quite valuable and versatile for the corrosion measurement of steel in concrete. See Fig. 4 for further illustration.

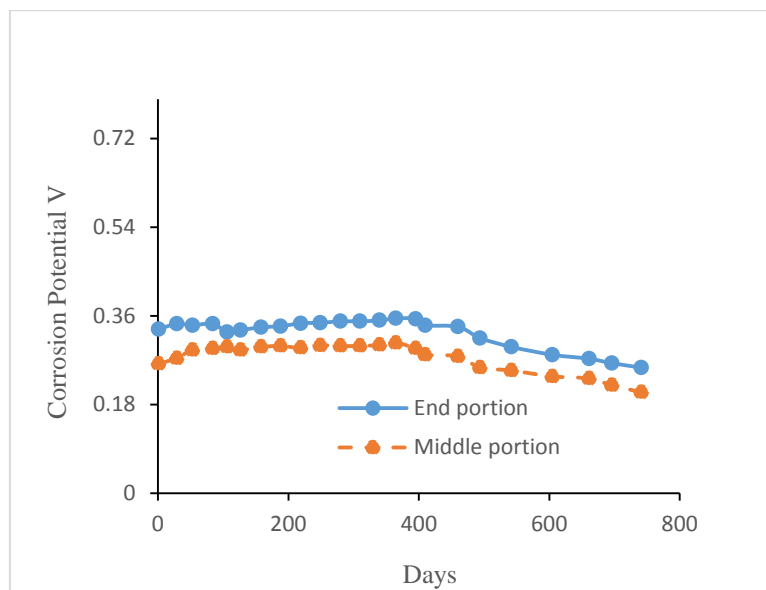
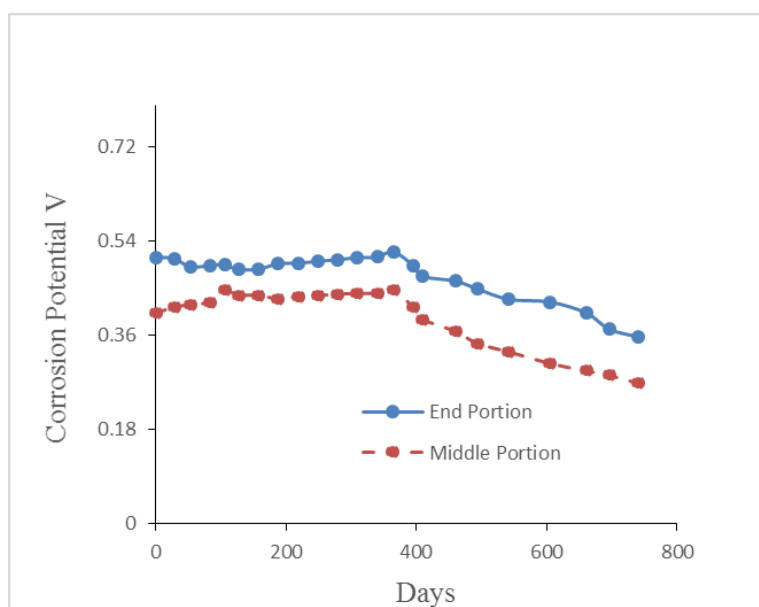
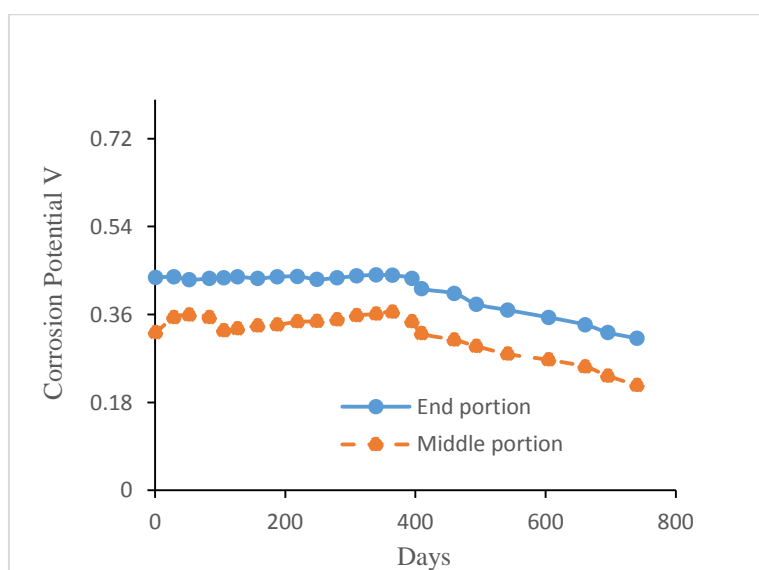
Fig. 6 (a-c) Corrosion potential measurement for 3% chloride contaminated specimen at the end kept at 30°C, 40°C and 50°C

5) In the 3 % chloride contaminated specimens (#7 and #8) at the end, the corrosion potential of **-0.255** Volts was obtained as compared to high **-0.311** Volts of same specimens (#11 and #12) which were kept at 30 °C.

6) In specimen #7 and #8, the corrosion potential of **-0.205** volts at the middle non contaminated portion was obtained as compared to **-0.215** Volt at 30°C.

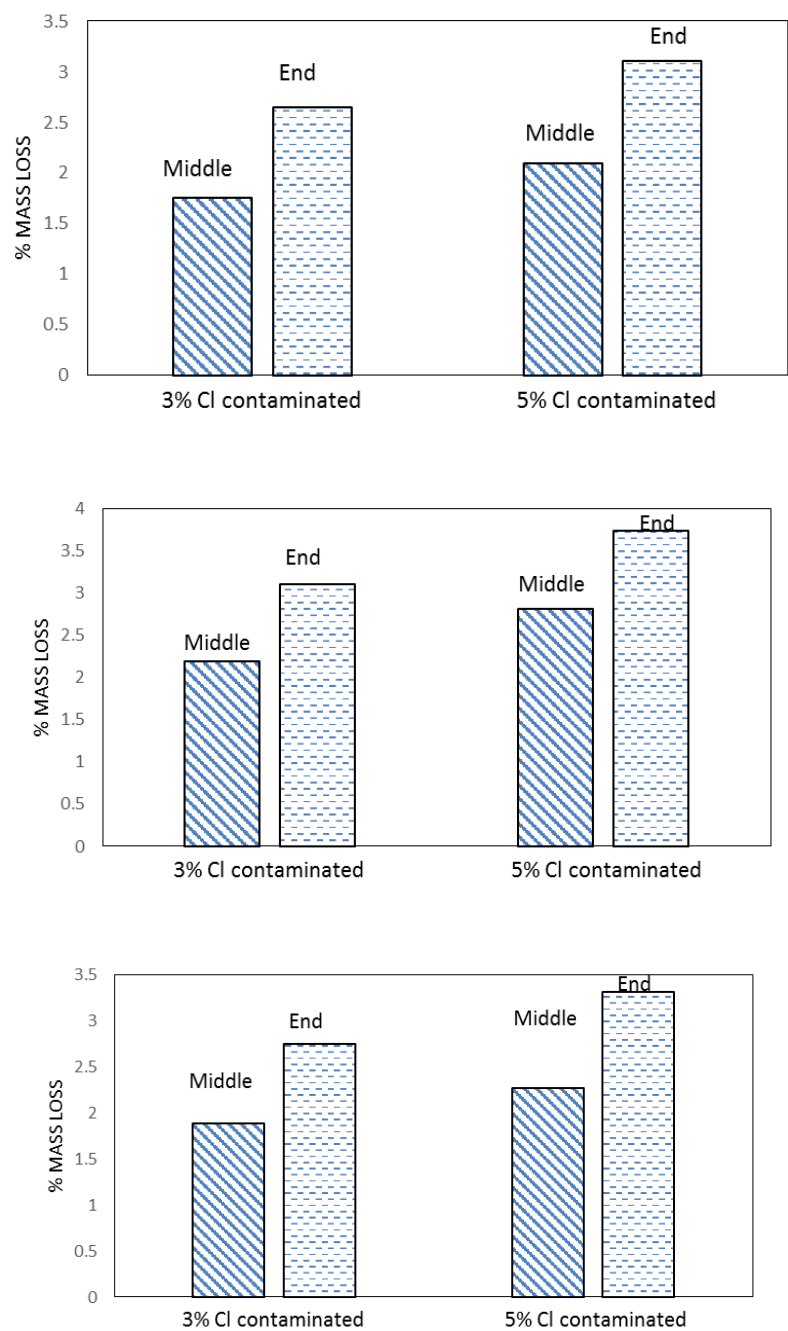
Fig. 7 % Mass loss for 3% and 5% chloride contaminated specimen at the end kept at 30°C, 40°C and 50°C

1) The steel bar from the end portion of 5% chloride contaminated concrete gave the highest % mass loss of 3.73 at 40°C while the steel bar from its middle portion gave 2.81 % mass loss. When the steel taken from the end portion of the same specimen kept at 30°C gave the highest % mass loss of 3.11 and 2.09 % obtained from its middle steel. However interestingly even after exposure of two years observation, the

steel of the end portion of the same specimen kept at 50°C gave the highest % mass loss of 3.31 and middle steel gave 2.27 % mass losses which was lower than the mass losses at 40°C. The results are shown in Fig. 7.

2) The steel from the end portions of 3 % chloride contaminated concrete specimens kept at 30°C, 40°C and 50°C gave 2.65, 3.11 and 2.75 % mass loss respectively. While the middle steels from the uncontaminated portion of these specimens gave 1.75, 2.19 and 1.88 % mass losses respectively as shown in figure 7. Similarly in the 3% chloride contaminated specimens reduced % mass losses at 50°C obtained as compared to the mass loss at 40°C, confirming the authenticity of the results of this research.

As it can be seen from gravimetric mass loss results of various specimens put in varying temperatures, shown in figure 7(a-c), the steels from the middle portion of all the specimens simulating the actual patch repair in field, were corroded and gave approximately 70% of the mass loss obtained in their respective contaminated end portions, indicating the chloride transfer and vulnerability of repaired portion against corrosion.
