Repair of Earthquake-Damaged Square R/C Columns with Glass Fiber-Reinforced Polymer

Abstract: This paper presents an experimental study on seismic repair of damaged square reinforced concrete columns with poor lap splices, 90-degree hooks and widely spaced transverse bars in plastic hinge regions according to ACI detailing (pre.1971) and (318-02) using GFRP wraps. Three specimens were tested in "as built" condition and retested after they were repaired by glass fiber-reinforced plastic sheets. They were tested under numerous reversed lateral cyclic loading with a constant axial load ratio. FRP composite wraps were used for repairing of concrete columns in critically stressed areas near the column footings. Physical and mechanical properties of composite wraps are described. Seismic performance and ductility of the repaired columns in terms of the hysteretic response are evaluated and compared with those of the original columns. The results indicated that GFRP wraps can be an effective repair measure for poorly confined R/C columns due to short splice length and widely spaced ties with 90-degree anchorage hooks. Both flexural strength and ductility of repaired columns were improved

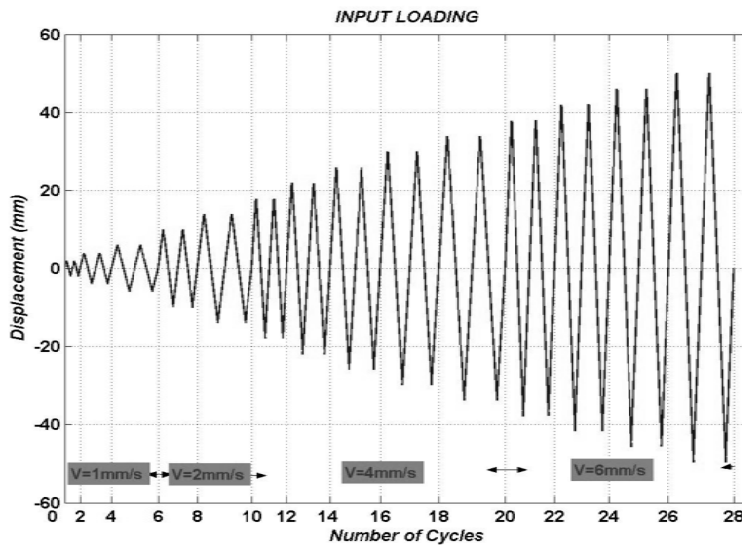
Fig.11 Lateral displacement history

Predefined cyclic lateral displacements with 28 cycles were subjected to specimens while the axial load was constant at either $(0.05f_c Ag)$ or $(0.15f_c Ag)$. Each prescribed drift level repeated twice in order to measure the strength degradation of the specimens. The rate of the applied displacement is shown in Fig. 11.

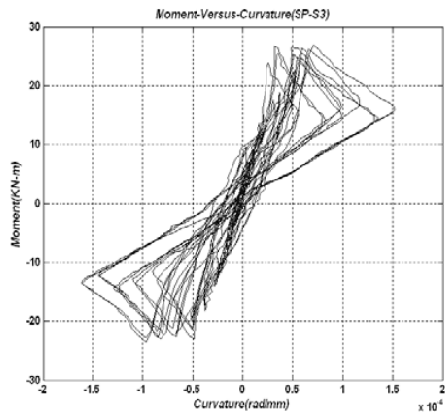
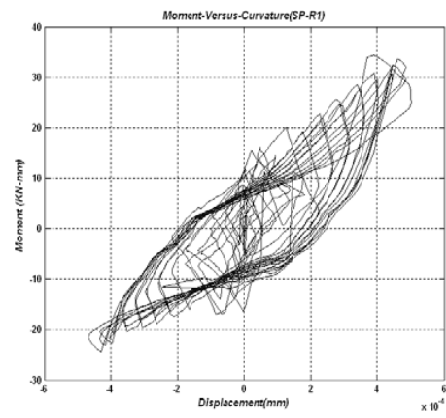
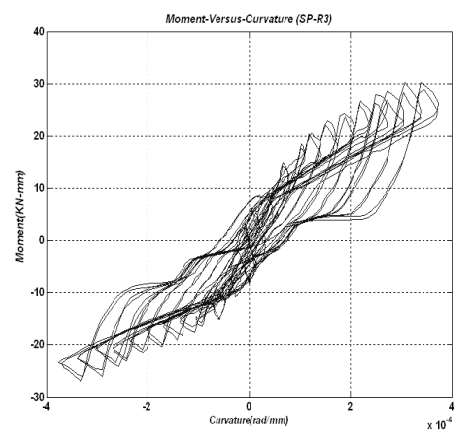
a) SP-S1

b) SP-S2

c) SP-S3

d) SP-R1

e) SP-R2

f) SP-R3

Fig.13 Moment –Curvature diagrams of the specimens

Behavior of a specimen under loading, was graphically represented in the form of a relationship between the hysteretic moment and the curvature of the section. Stiffness degradation and distribution of cracks were studied in the as built and also the repaired columns. In each cycle the lateral load and the deflection at free end of the columns were recorded and the crack patterns were registered during the tests.

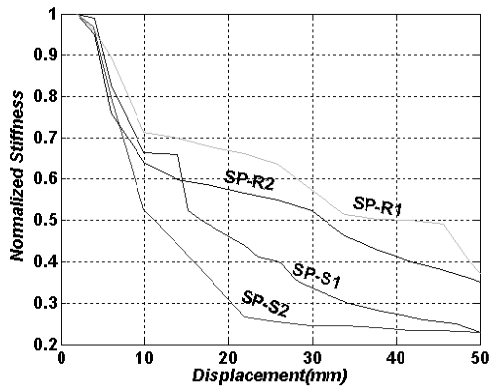
Fig.15 Normalized Stiffness versus Displacement for SP-S1, SP-S2, SP-R1 and SP-R2

Stiffness for each cycle was calculated as the average of the stiffness for the positive and negative directions. Stiffness for each cycle was normalized with respect to the stiffness of the first cycle and was plotted versus the displacement. Stiffness degradation versus column top displacement after normalization is plotted in Fig.15 and Fig.16.
