# FATIGUE BEHAVIOUR OF A ROLLED AZ31 MAGNESIUM ALLOYS PREPARED BY EP AND BB CONDITIONS

Abstract: Rotating bending fatigue tests have been performed using smooth specimens of a rolled AZ31 magnesium alloy in laboratory air at ambient temperature. Fatigue strength and characteristic was evaluated and fracture mechanism was discussed on the basis fracture surface analysis. Electrical polishing (EP) as well as deep rolling (ball burnishing (BB)) U-notched specimens were performed on two groups of samples, to evaluate optimum conditions for fatigue life. The microstructure and tensile properties of roll cast (RC) Mg- 3% Al- 1% Zn (AZ31) was investigated. The fatigue strength of 107 cycles around 100 MPa for deep rolling while it was around 40 MPa for Electrical polishing. It was very important to understand the effect of (ball burnishing (BB)) conditions on the hardness of the surface through to the core. The two procedures improved the fatigue performance, but better improve in results were found in ball burnishing. The growth of small cracks initiated at the surface coincided with the FCP characteristic after allowing for crack closure for large cracks, but the operative fracture mec

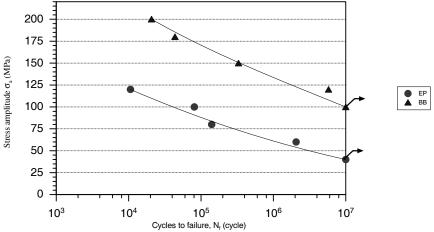
Fig.2. S-N curve for rolled AZ31 at EP,BB conditions, rotating beam, R=-1, 50Hz.

S/N curves for the EP and the BB specimens in laboratory at a stress ratio of -1 and frequency of 50 Hz (rolled magnesium alloy) in laboratory air is shown in Fig. 2. In this figure, for comparison purposes, the S-N curves of the EP and BB specimens are shown respectively. As seen from the figure, the fatigue life of the rolled magnesium alloy of EP specimen is relatively shorter than that of BB specimen. The extent bending in the S-N curve is gentler in the BB specimens than in the EP specimen. Next let us compare the S-N characteristics of the EP and BB specimens. There are great differences in the fatigue lives and in the fatigue limits, especially at higher stress amplitudes, there are differences in the fatigue lives.

4. Subsurface crack initiation occurred at applied stresses at 60 MPa. At BB condition but it can be seen for both 80 and 100 MPa stress for EP condition. The S–N diagram is shown in Fig. 2. It is well known that fatigue limit does not exist in non-ferrous alloys, thus fatigue tests were continued until  $10^7$  cycles. At EP condition  $\sigma$ = 40 MPa, fatigue failure did not occur, but non-propagating cracks were observed on the specimen surface. As can be seen in the figure, the present Mg alloy seems to possess a definite fatigue limit, which may be related to the existence of non-propagating cracks. The fracture mode depending

1. Fatigue strength at 10<sup>7</sup> cycles was 100 MPa

for BB condition with the following preparation condition on ECOROLL instrument using tool type (HG6) at 100 bar (246 N) with feed rate of 0.17 mm/min at 30 rpm. While the fatigue strength at 107 cycles was 40 MPa for EP condition.

- 2. Fatigue lives and the fatigue limit of BB specimens were higher than those of EP specimens with similar profiles.
- 3. Electrical polishing and ball burnishing preparation are very sensitive to working procedure of choosing temperature for EP or in choosing (Feed, Speed and tool head) for BB condition. After many trails to find out the good combination of the three parameters.
- 4. As a result of crack initiate from the surface for EP condition it fails under lower stress than in BB condition which crack initiate internally (as surface treated by BB).
- 5. It could be investigate the best condition of BB by examine the surface up to 500 ?m for microhardness value, to choice best values for BB treatment.

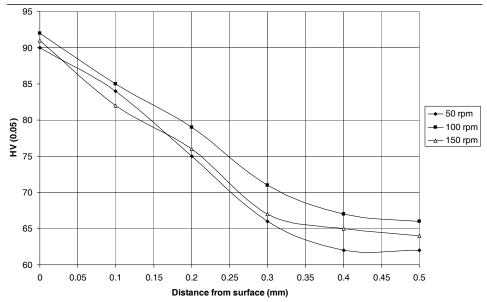
Fig. 3. Microhardness profile oif AZ31 after BB at 200 bars, 0.17 mm/min at different BB rotation speed.

**3. 3.** A different experiment were used to investigate the best condition for BB (pressure, feed rate, speed) as example for tool HG3 200 bar (123 N) for 50, 100 and 150 rpm. The microhardness measurement from the surface in Fig. 3. Shows that the suitable condition for using 200 bars is 100 rpm for AZ31 as the hardness decreased from the circumference gradually to the center.

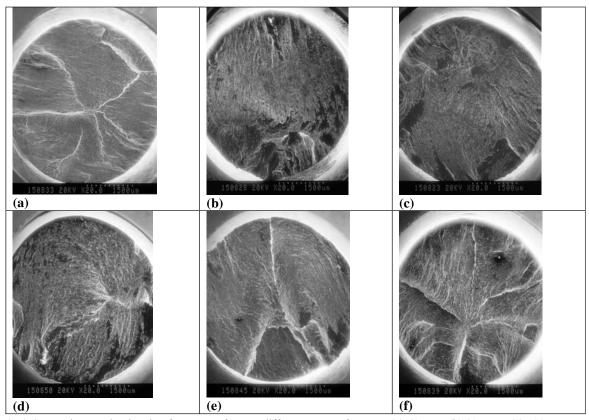
**Fig.4.** SEM micrographs showing fracture surfaces at difference stress for EP at (a) 60MPa; (b) 80 MPa; (c) 100 MPa and BB at (d) 60MPa; (e) 80 MPa; (f) 100 MPa.

The fracture surface of AZ31 for EP condition and BB condition at different stress is shown in Fig.

on applied stress level, above 60 MPa cracks initiate at the surface (surface fracture), while below that stress at the interior of the specimen (subsurface fracture). Subsurface fracture is a very interesting finding, which has not been recognized in Mg alloys, for both EP and BB conditions.

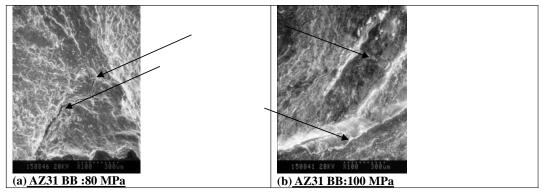
Fig. 5. SEM micrographs showing cracked surfaces at difference stress for BB at (a) 80MPa; (b) 100 MPa

The cracked line could be seen easily for higher stress for BB condition as fracture occurs in internal surface not at the outer surface as in the EP condition in Fig. 5.
