AN INVESTIGATION ON EFFECT OF BOND COAT REPLACEMENT ON HOT CORROSION PROPERTIES OF THERMAL BARRIER COATINGS

Abstract: In the present study NiCrAlY bond coating layer was produced by electroplating against common atmospheric plasma spraying (APS). Both types of the bond coats were applied on IN738LC base metal then, the YSZ (ZrO_2 -8% Y_2O_3) thermal barrier top layer was coated by atmospheric plasma spray technique. Hot corrosion is one of the main destructive factors in thermal barrier coatings (TBCs) which come as a result of molten salt effect on the coating-gas interface. In this investigation the hot corrosion behavior of coatings was tested in the furnace which was contain Na_2SO_4 -55% V_2O_5 and mixed salts environment at 900°C up to 15 hr. dwell time. Optical microscopy, scanning electron microscopy (SEM / EDS) and X-ray diffraction analysis (XRD) was used to determine the crystallographic structure and phase transformation of the coatings before and after the hot corrosion tests. The transformation of tetragonal Zirconia to monoclinic ZrO_2 and formation of YVO_4 crystals as hot corrosion products caused the degradation of mentioned TBCs. The results showed NiCrAlY coate

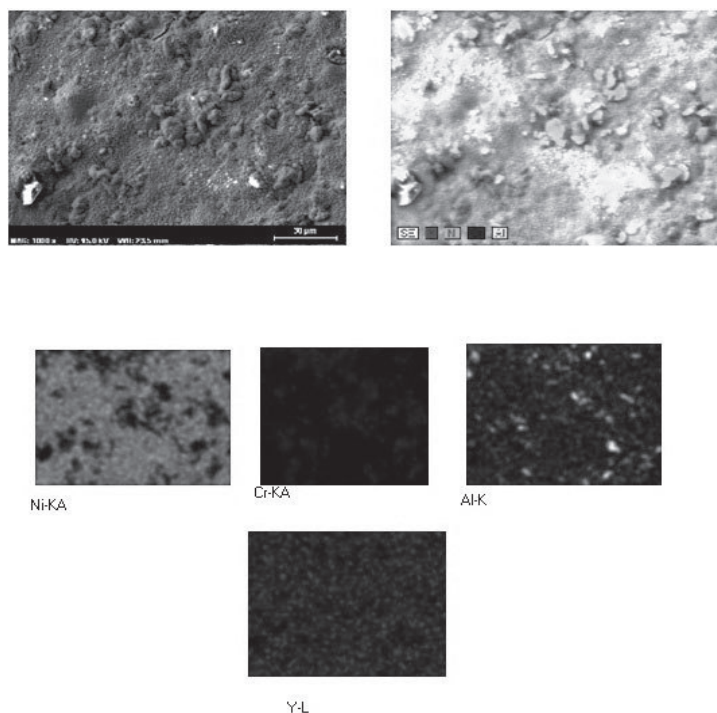
map from scanning electron microscopy of electro co-deposited and heat treated bond coat surface were presented in Figure 3. It can be seen uniform distribution of Ni, Cr, Al and Y in the

bond coat. Therefore, Heat treatment makes a completely homogenization and diffusion of the coated elements to gather because of reducing holes, surface roughness and uniform distribution

of elements after the heat treatment cycle. So the heat treatment makes a good uniformity in the structure and alloying of the coating.

Fig. 3. Image of X-Ray Map of nickel, chromium, yttrium and aluminum NiCrAlY coating after heat treatment at 1000 ° C for 2 hours

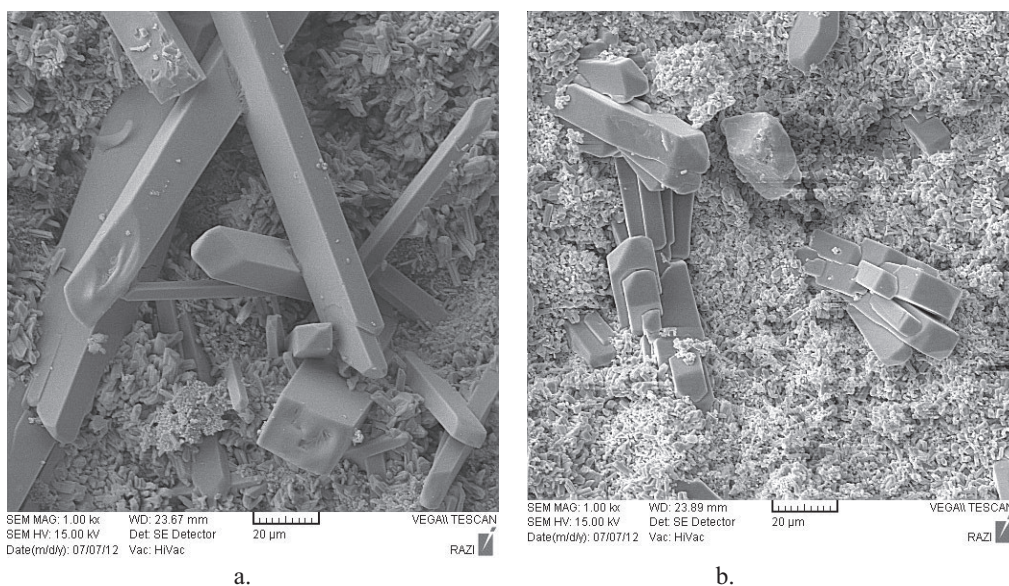
Fig. 7 shows the SEM surface morphology of the coatings and corrosion products after 6 h of corrosion testing. Usual TBC (NiCrAlY plasma spray +YSZ plasma spray) and (NiCrAlY electroplating +YSZ plasma spray) coatings revealed a porous surface having some cracks and many dendrite YVO_4 crystals grown on the

Fig. 7. SEM micrographs of YVO_4 crystals on the surface of coatings: (a) NiCrAlY-YSZ; (b) Ni-Cr-Al-Y-YSZ.

surface (Fig. 7 a and b).

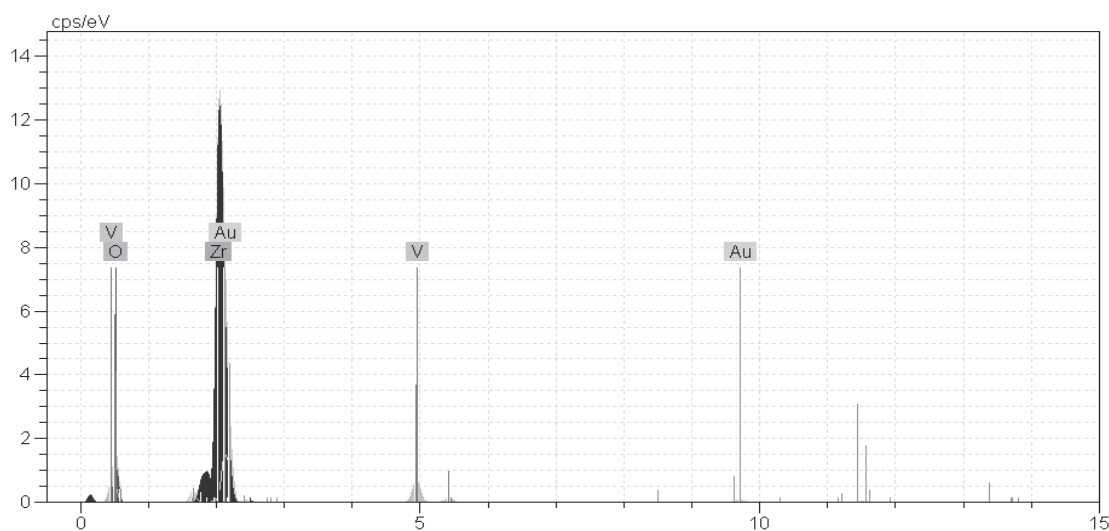
Fig. 8. EDS spectrum from the surface of the hot corroded coatings.

EDS analysis from the surface of the hot corroded coatings (Fig. 8) demonstrated that the crystals were composed of yttrium, vanadium and oxygen, then they were identified by XRD analysis to be YVO_4 .

- Molten salt penetration through micro cracks and open porosities.
- Reaction of molten salt with the stabilizer of zirconia (Y_2O_3).
- Phase transformation of zirconia from tetragonal to monoclinic, due to the depletion of stabilizer, which is accompanied by volume expansion of the coating.
- Formation of YVO_4 crystals with rod shape and average length of 40 μm usual YSZ coating that grow to outward of surface and cause additional stresses in the coating (Fig. 8) [6, 9- 10].
